ADVANCED STRUCTURES CONCEPTS R&M/COST ASSESSMENTS

Thomas N. Cook, Bruce F. Kay
Sikorsky Aircraft Division
United Technologies Corporation
Stratford, Conn. 06602

September 1979

Final Report for Period October 1977 - February 1979

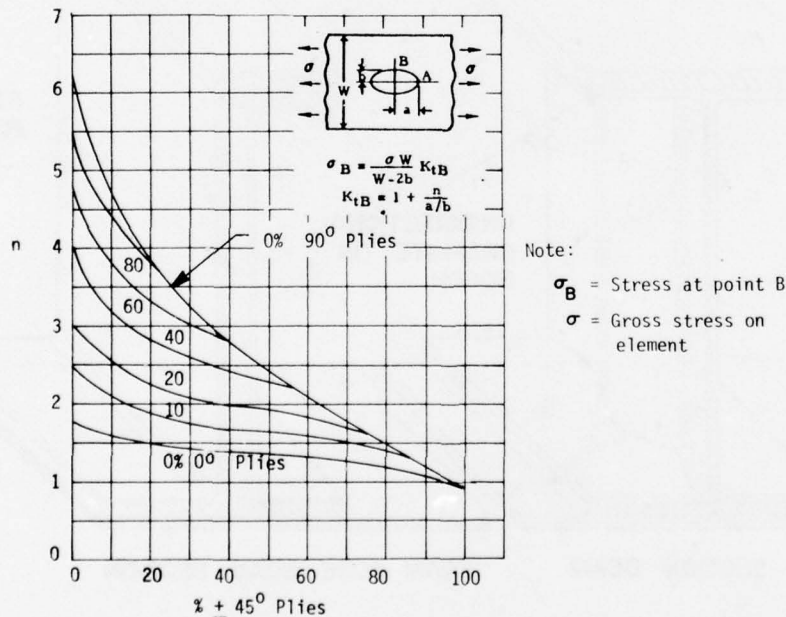
Figure 7. Stress Concentration Factor at Point B, High-Strength Graphite/Epoxy

For example, Figure 7 shows that the stress concentration factor for a hole drilled in unidirectional graphite/epoxy is approximately seven. That is, the stress in a drilled structure is increased approximately 700% over that in an undrilled structure. Mechanical fasteners cannot be placed in composite structures unless the structure has been designed to accommodate them. Special considerations must be given to the layup of local reinforcements where mechanical fasteners are used.

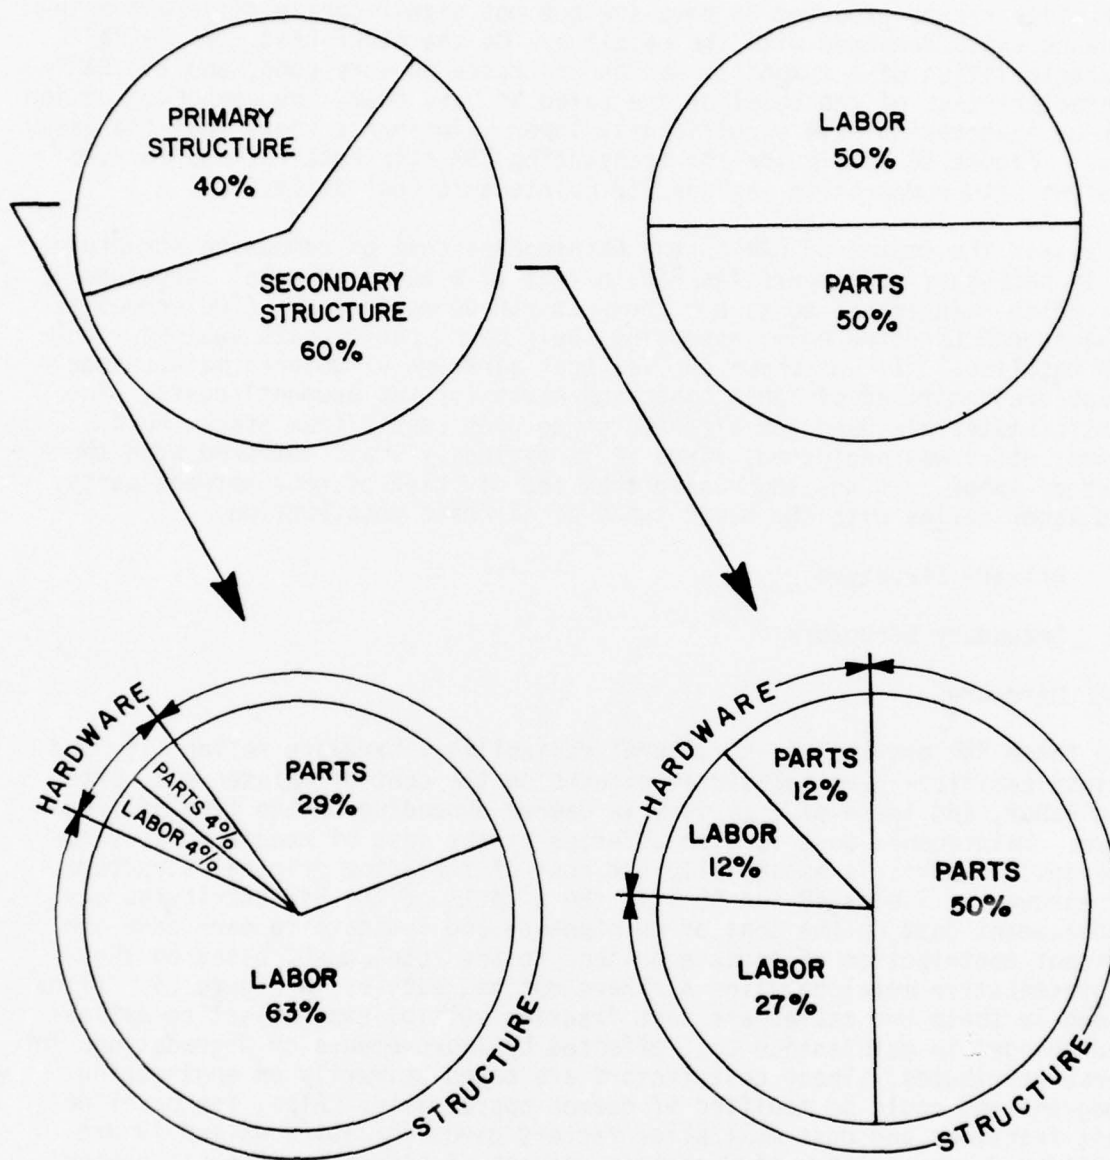
Figure 85. Division of Airframe Maintenance Costs

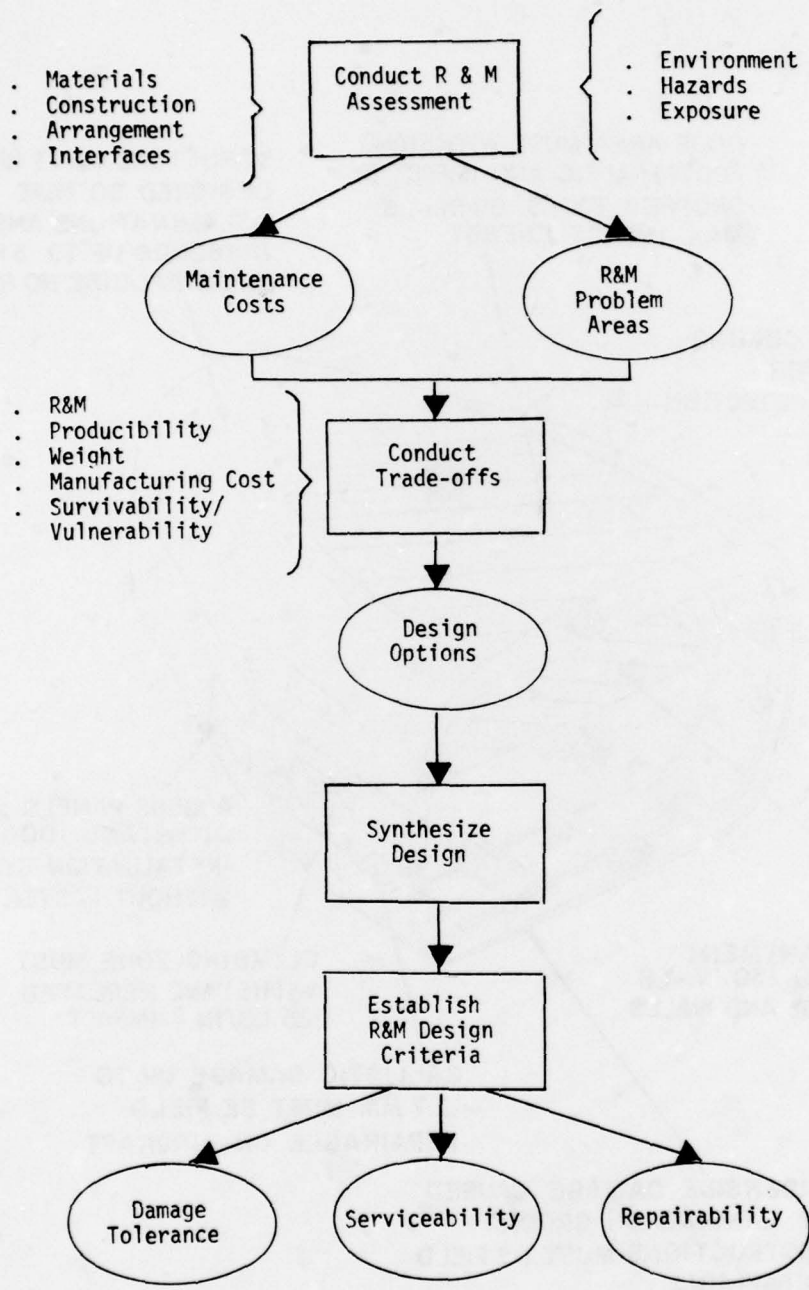
Figure 96. Flow of R&M Activities During Preliminary Design

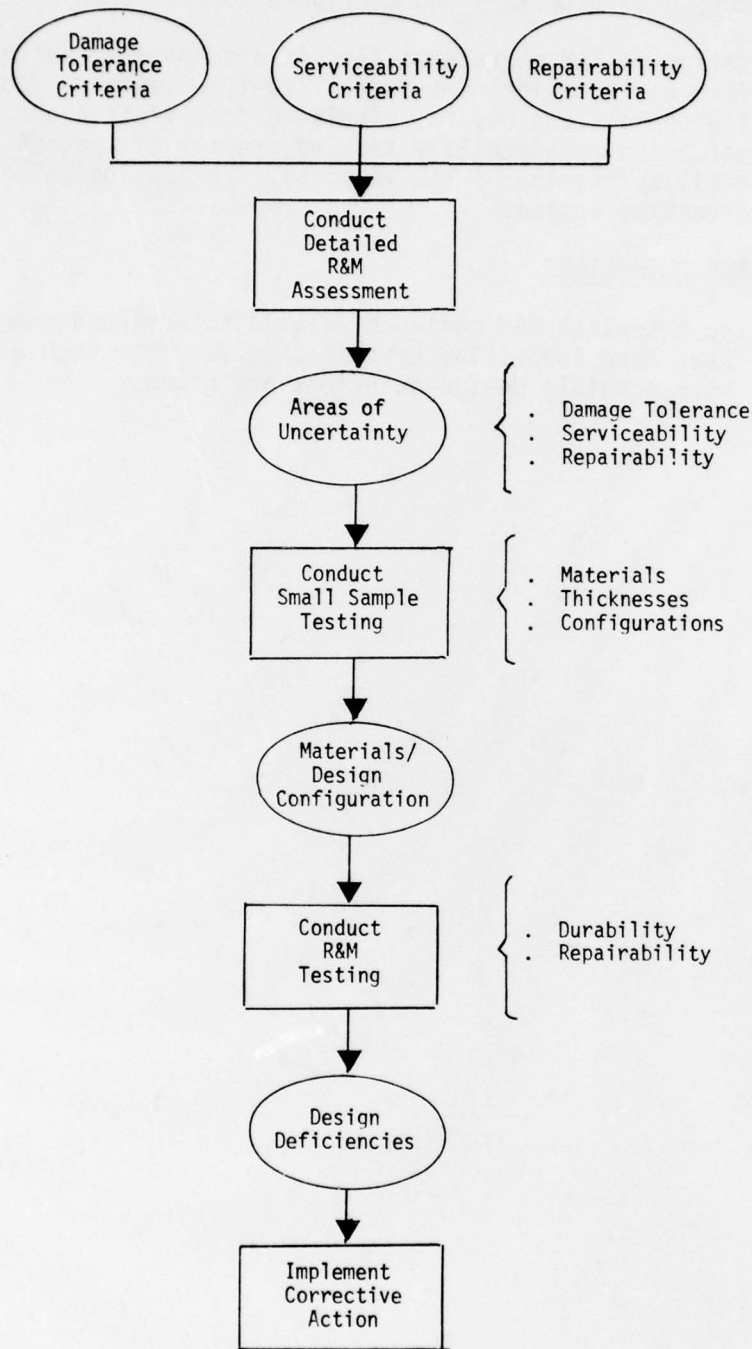
Figure 98. Flow of R&M Activities During Detailed Design and Development

Figure 98 outlines the suggested flow of R&M activity during the detailed design and development phase. Prior to the start of design, a detailed R&M assessment is made of the final preliminary design concept. Areas of the design appearing not to satisfy the established R&M criteria are discussed and resolved with the designer. Where published data leaves uncertainty about the probable performance of materials in service (damage tolerance,
